**Re: Seeping Springs Trout Lakes and RV Park; Minor; SIC 7033; NPDES Reconnaissance Inspection; NPDES #NMU001976; August 28, 2018**

**Seeping Springs Trout Lakes and RV Park  
Reconnaissance Inspection  
NPDES Tracking No. NMU001976  
August 28, 2018  
Further Explanations**

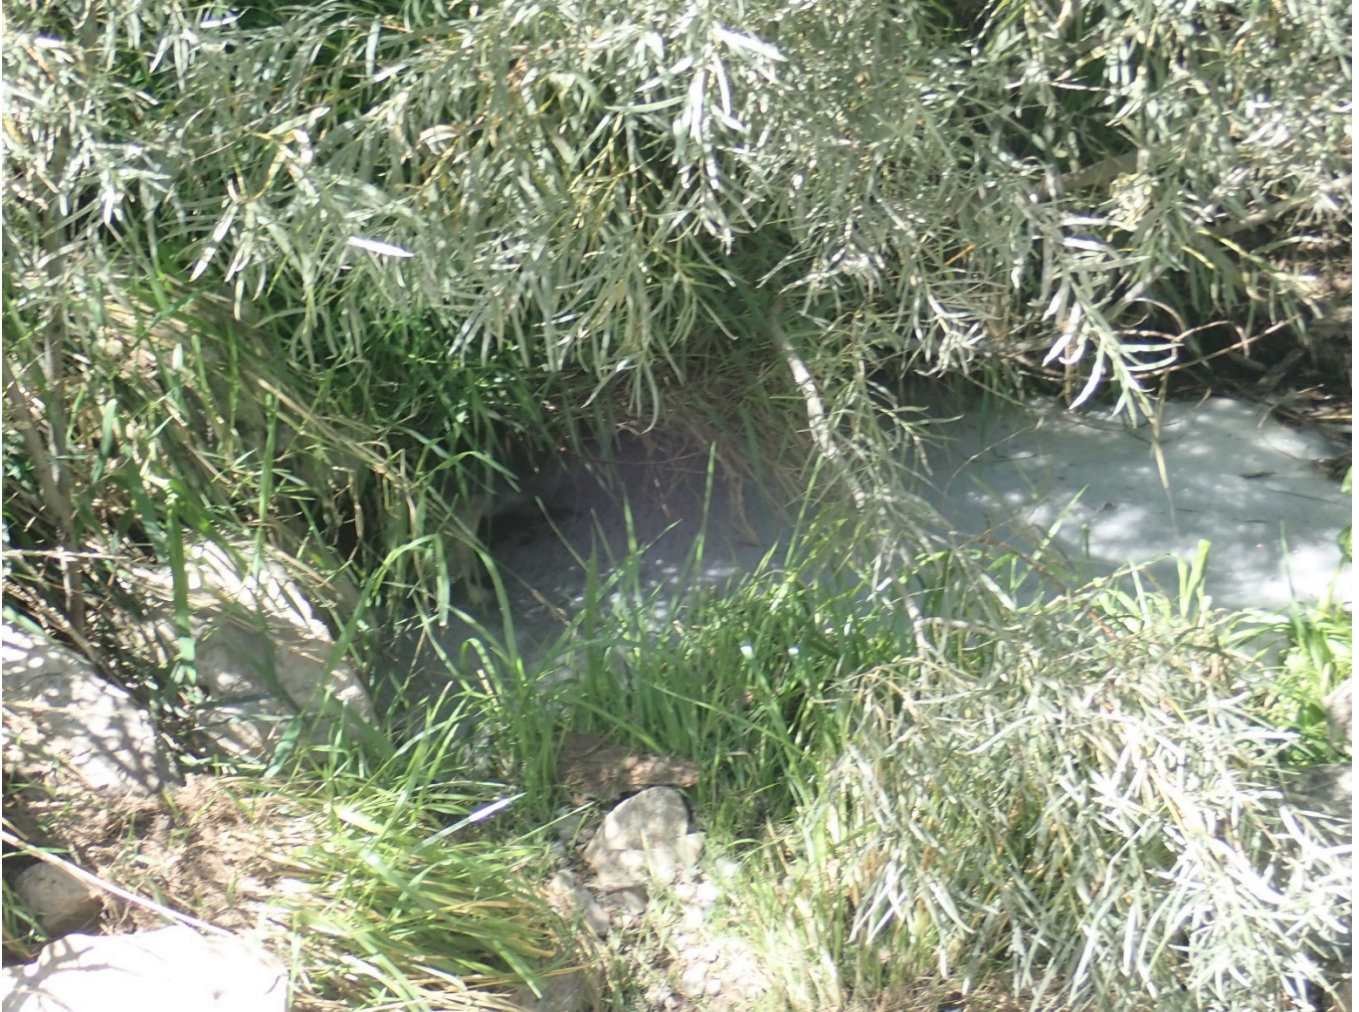
**NMED/SWQB**  
**Official Photograph Log**  
**Photo # 2**

On August 27, 2018, while inspecting an adjacent NPDES Permitted outfall to the Rio Ruidoso, a separate discharging pipe was observed with a soapy foamy discharge. The source of the piping is unknown. The vegetation near the pipes was very thick and was difficult to move through to get a better look without falling in the water. The inspectors did not have sampling equipment. The NMED liquid waste and groundwater bureaus were contacted and they were not aware of any permits for the facility.

Subject: Soapy foam at concrete pipe

If the facility is the source of the foam, they must halt the unpermitted discharge of pollutants to the Rio Ruidoso.

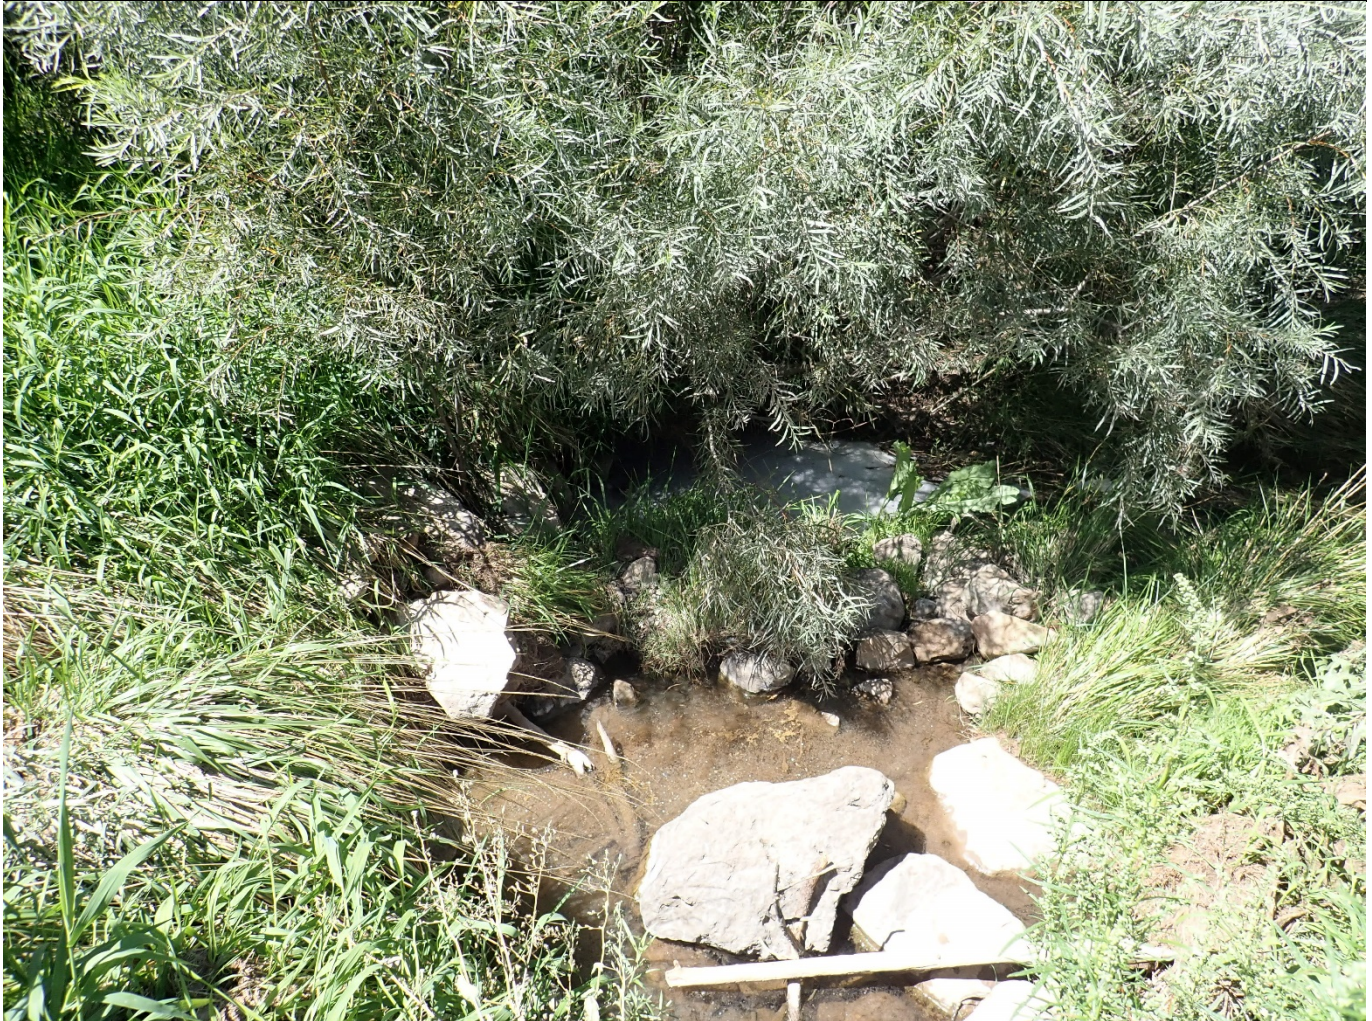
**NMED/SWQB  
Official Photograph Log  
Photo # 3**

Photographer: Jennifer Foote	Date: 8/28/18	Time: 1:58 pm
City/County: Ruidoso Downs/Lincoln County		State: New Mexico
Location: Seeping Springs RV Park		
Subject: Clear water next to discharge at concrete pipe
